## Geoelectric Study of Dam Site of Federal College of Agriculture Akure Southwestern Nigeria

**Abstract:** Geophysical investigation has been undertaken at an existing dam site within the campus of the Federal College of Agriculture, Akure. This is aimed at evaluating the geophysical characteristics of the bedrock along the dam axis and its banks. The survey involved the use of electrical resistivity (VES) depth sounding technique. The Schlumberger electrode configuration was adopted for the field study. Thirty-three soundings were undertaken on nine traverses that were established in North-South directions on the Western (W1-W3) and Eastern (E1-E3) flanks and West-East traverses established on the Southern end of the dam (S1-S3). The three major litho logy units delineated are the topsoil, weathered basement and the presumably fresh/fractured bedrock. The geoelectric section revealed a network of lineaments presumed to be fractures on the S1-S3 and W1-W3 profiles. The geoelectric maps show high resistivity contours straddled with low resistivity lines characterizing the eastern flank thus indicating near-surface bedrock straddled with a basement depression or fracture. The prese

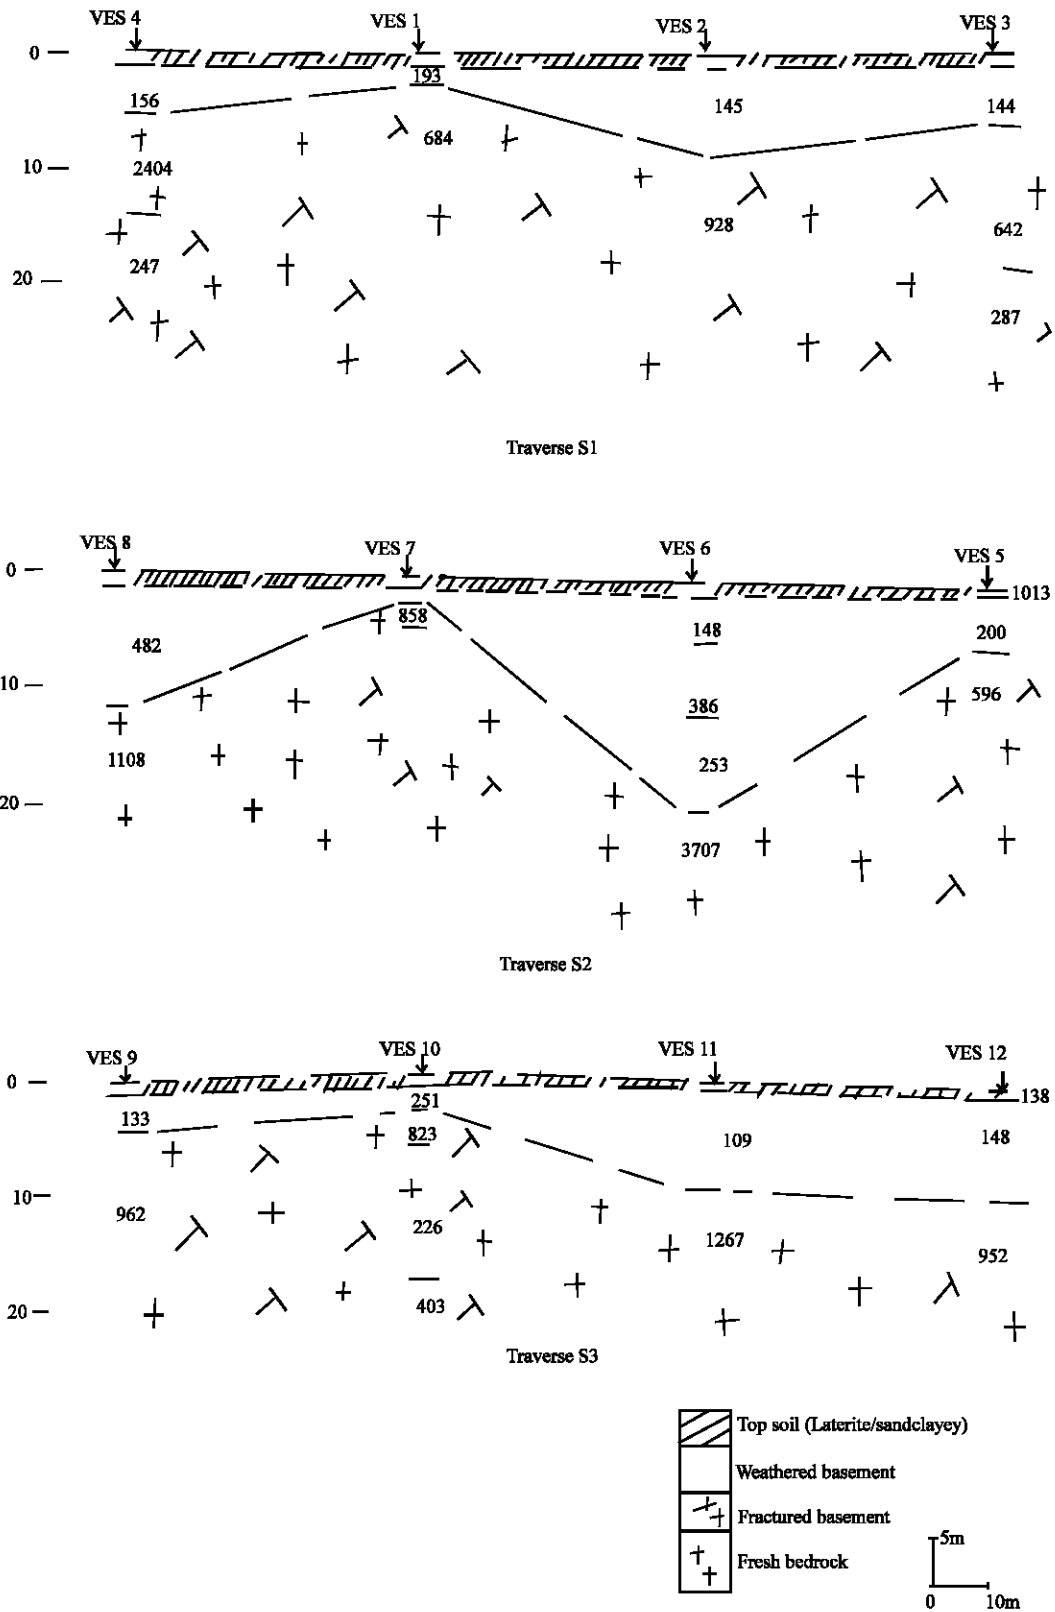
Fig. 5: Geoelectric sections along traverses S1-S3

The granitic nature of the underlying rock is observed on the outcrop within the reservoir at about 8m north of VES 1. The bedrock resistivity values range from 1029 to 52,134  $\Omega$ -m (infinitely resistive). This is diagnostic of partially weathered basement to fresh bedrock. Basement fracturing was observed on thirteen locations. They are VES 1, VES 2, VES 3, VES 4, VES 5, VES 6, VES 7, VES 9, VES 10, VES 13, VES 14, VES 18 and VES 21 on profiles S1-S3 and W1-W3. The resistivity values diagnostic of fractures in the dam environment

vary from 110 to 952  $\Omega$ -m. Their presence is not considered ideal for good dam performance and dam safety. The existence of fractures is generally accompanied by high fluid streaming potential. Hence, substantial water may be lost through the fractures thus initiating the weakening of the dam foundation. Geoelectric attributes indicative of sandy clay, clayey sand observed in the weathered layer were obtained from curve types associated with thick overburden (i.e., HA, KH and HKH).

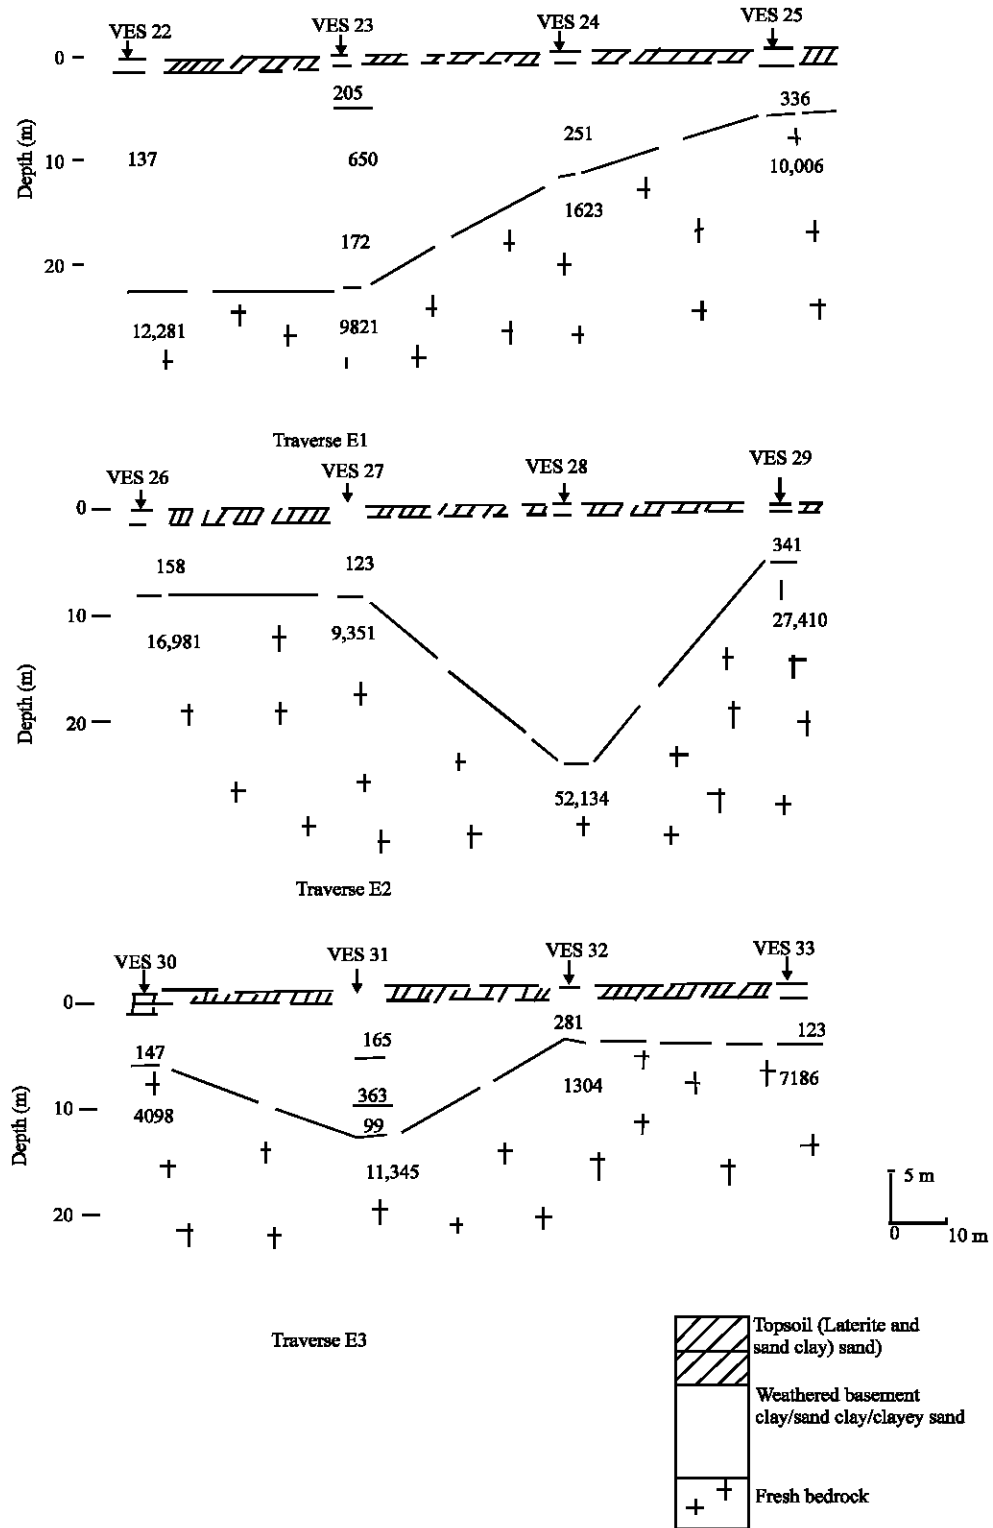
Fig. 6: Geoelectric sections along traverses E1-E3

**Geoelectric sections:** 2-D geoelectric sections along profiles S1-S3, E1-E3 and W1-W3 are presented in Fig. 5-7, respectively. Three major geoelectric layer units were delineated beneath the sections. These are the topsoil, weathered basement and the fractured/fresh resistive bedrock. The topsoil consists of laterite/clayey sand/sandy clay with resistivity values varying from 136 to 3132  $\Omega$ -m. Layer thickness varies between 0.6 and 1.6 m. The weathered layer which has resistivity and thickness varying from 73 to 771  $\Omega$ -m and 0.7 to 21.6 m, respectively consists of clay/sandy clay/clayey sand/sand. The third layer constitutes the bedrock.

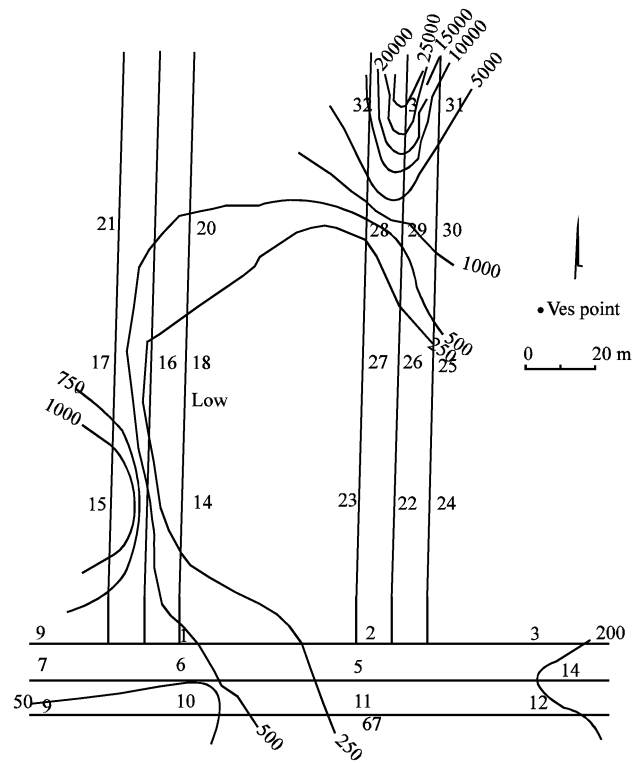
Fig. 8: Resistivity distribution map at depth of 5 m

Figure 8-10 shows the resistivity variation maps at depths of 5, 10 and 15 m. At 5m depth, the resistivity map is characterized by low resistivity values ( $\leq 500 \Omega$ -m) in the southern and western flanks. The northeastern flank is characterized by higher resistivity values ( $> 500 \Omega$ -m). The higher resistivity zone presupposes the existence of near surface bedrock and vice-versa for the low resistivity areas. At 10 and 15 m depths, (Fig. 9 and 10) more resistive basement rock areas were intercepted. This was indicated by high resistivity values ( $> 1000 \Omega$ -m) obtained. The attitude of the contour lines show strike direction features of the concealed bedrock to be approximately North-South. A localized bedrock depression whose axis correlate with the low resistivity zone ( $\leq 500 \Omega$ -m) marked F-F' was delineated. A basement depression correlated over a significantly long distance could be diagnostic of a buried river channel (Ako and Olorunfemi, 1989). However, this minor bedrock depression could not be correlated on the traverses on western flank.
