## Geoelectric Study of Dam Site of Federal College of Agriculture Akure Southwestern Nigeria

**Abstract:** Geophysical investigation has been undertaken at an existing dam site within the campus of the Federal College of Agriculture, Akure. This is aimed at evaluating the geophysical characteristics of the bedrock along the dam axis and its banks. The survey involved the use of electrical resistivity (VES) depth sounding technique. The Schlumberger electrode configuration was adopted for the field study. Thirty-three soundings were undertaken on nine traverses that were established in North-South directions on the Western (W1-W3) and Eastern (E1-E3) flanks and West-East traverses established on the Southern end of the dam (S1-S3). The three major litho logy units delineated are the topsoil, weathered basement and the presumably fresh/fractured bedrock. The geoelectric section revealed a network of lineaments presumed to be fractures on the S1-S3 and W1-W3 profiles. The geoelectric maps show high resistivity contours straddled with low resistivity lines characterizing the eastern flank thus indicating near-surface bedrock straddled with a basement depression or fracture. The prese

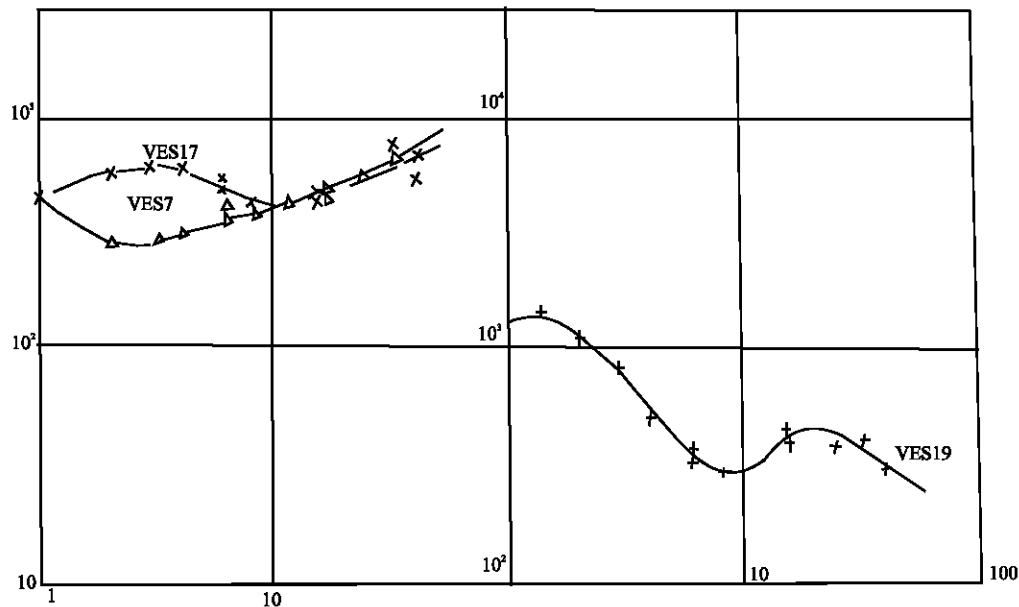
Fig. 4: Typical sounding curves obtained from the study area

Seven sounding curve types with geoelectric layers of between 3 and 5 were obtained in the study area. The observed curved types are H, K, HK, KH, HA, KHA and KHK. The 3-layer H curve type predominates while the 3-layer K was obtained at only one sounding location.
